TRIM Record: 2011AGF2303

Inspection Date: 8/15/2011

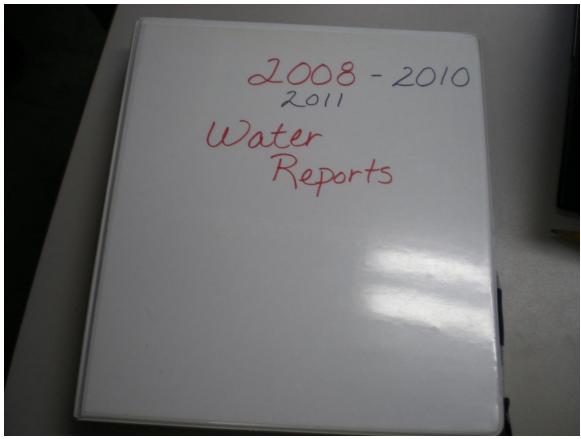
Figure 1. Cover of DMR binder. The binder is kept in the CHA offices.

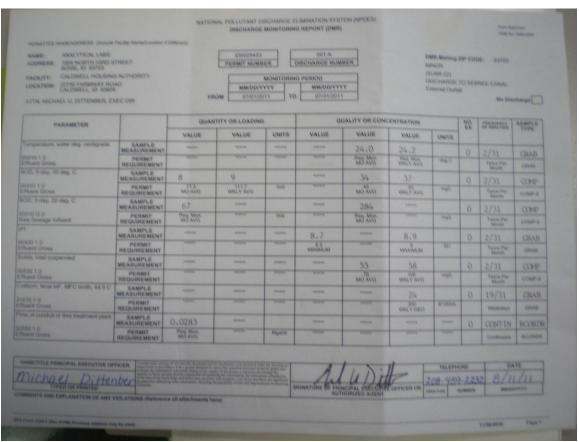
Figure 2. July 2011 DMR, page 1.

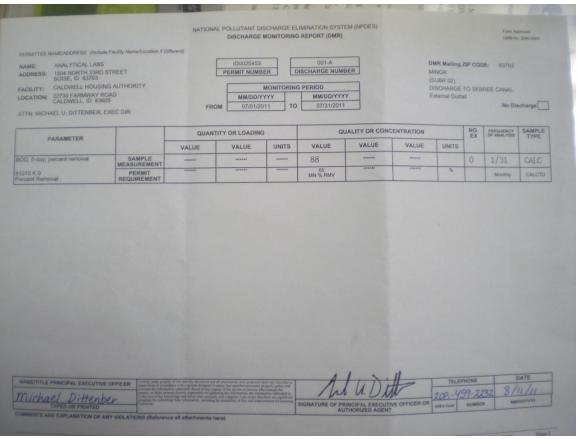
Figure 3. July 2011 DMR, page 2.

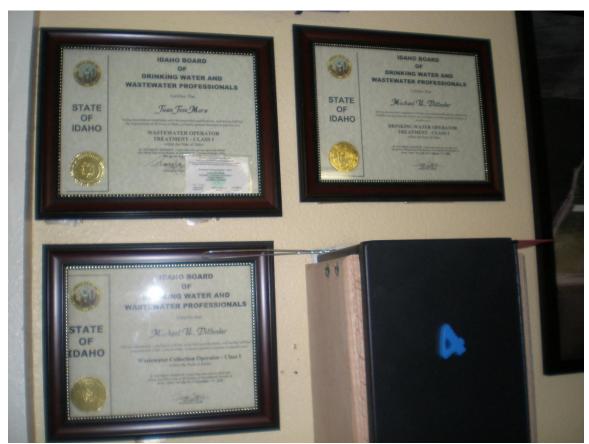
Figure 4. Operator licenses in CHA office. Please note that Juan Mora no longer works for CHA. Tom Krasowski (IES) is currently under contract with CHA as their certified Wastewater Collections and Treatment operator.

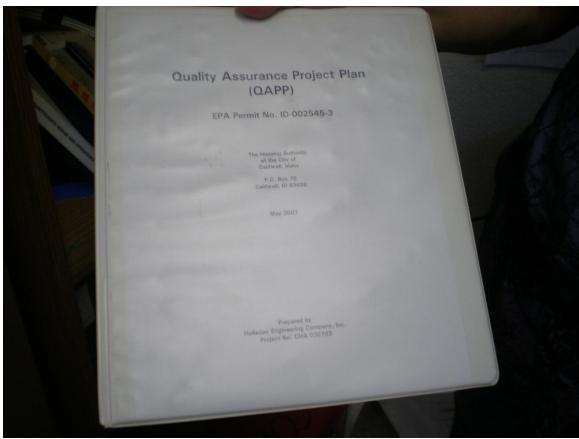
Figure 6. QAP cover.

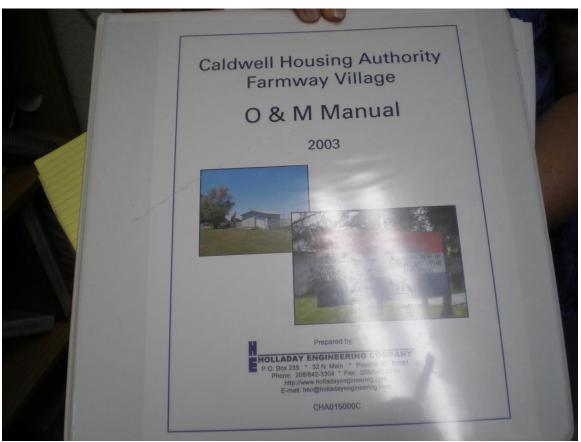
Figure 7. O&M Manual cover.

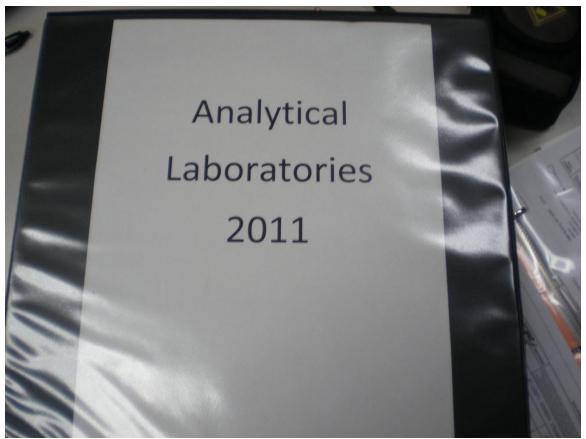
Figure 8. Contract laboratory QAP. Note that all analytical samples are collected by the contract laboratory.

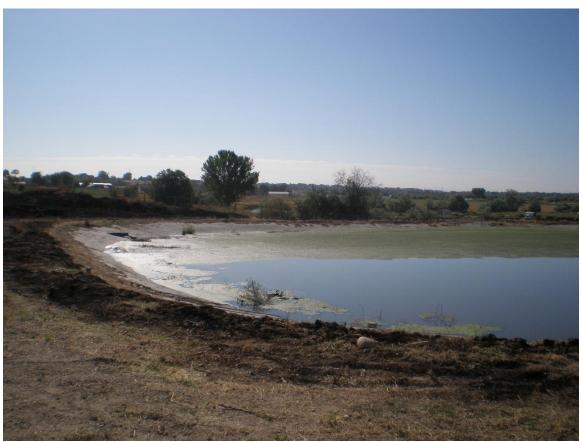
Figure 9. Looking east at Lagoon 1.

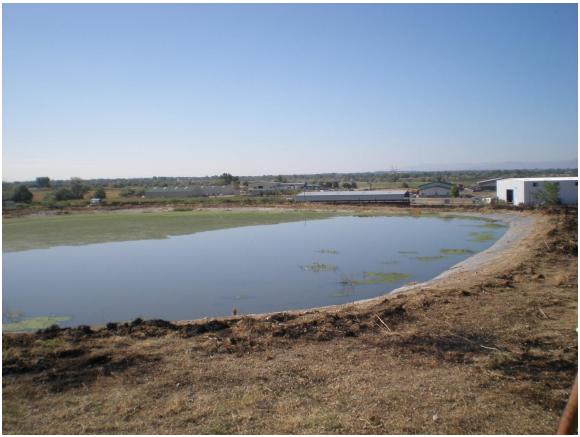
Figure 10. looking south at Lagoon 1. Aerator is in the shop being rebuilt.

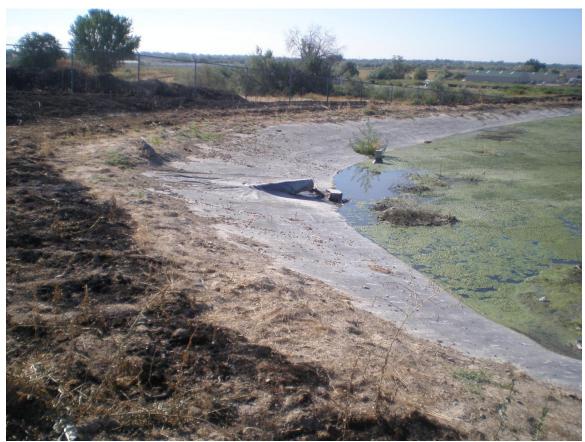
Figure 11. Close-up of influent pipe into Lagoon 1 (looking east).

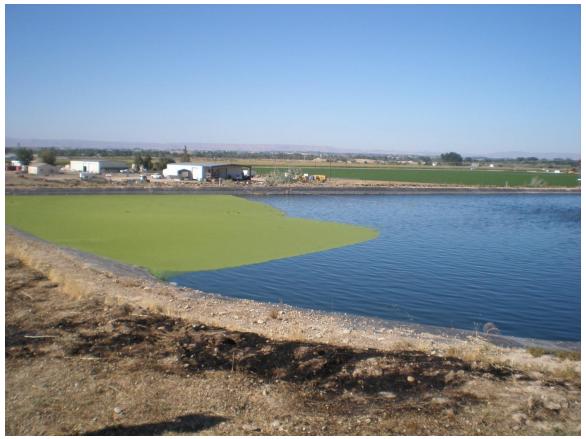
Figure 12. Looking south at Lagoon 2. Note duckweed growth at left of photo.

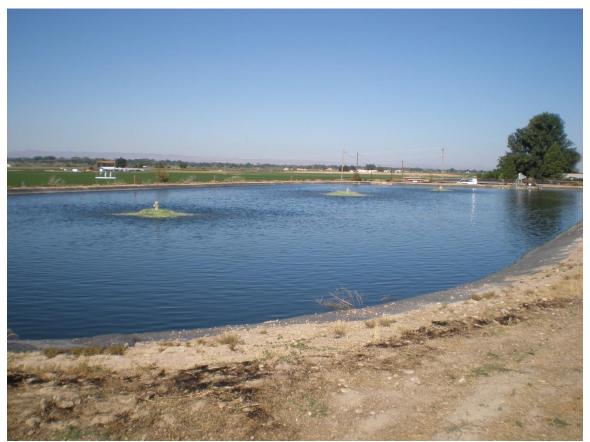
Figure 13. Looking southwest at Lagoon 2. Note that green color at aerators appears to be from duckweed.

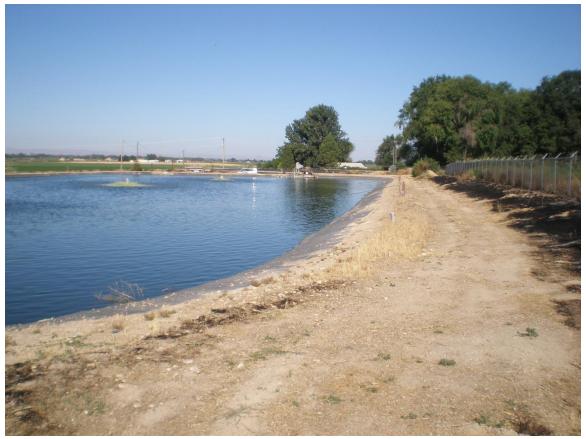
Figure 14. Looking west along north berm of Lagoon 2.

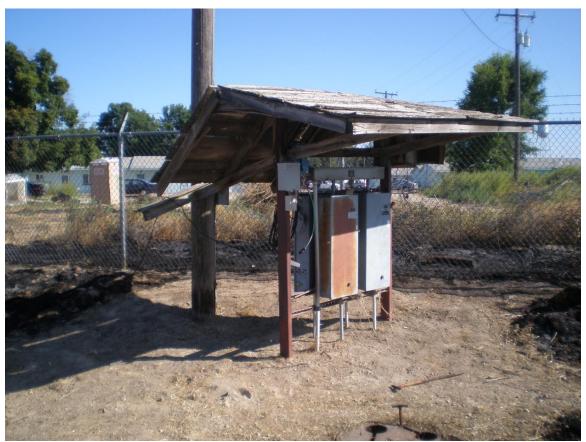
Figure 15. Electrical panel between Lagoons 1 and 2 at north edge of site.

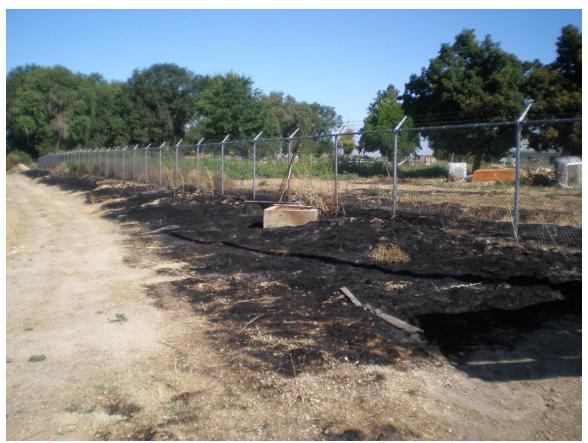
Figure 16. Parshall Flume meter box (concrete box at center of photo). Wiring runs along the ground surface through the burned area to the control panel located to the right (see Figure 15, above).

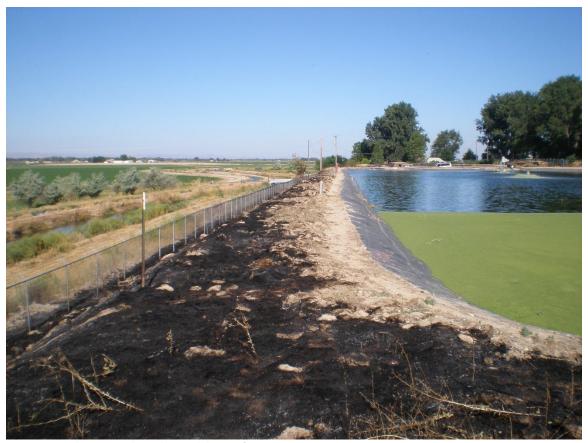
Figure 17. Looking west along the south berm of Lagoon 2.

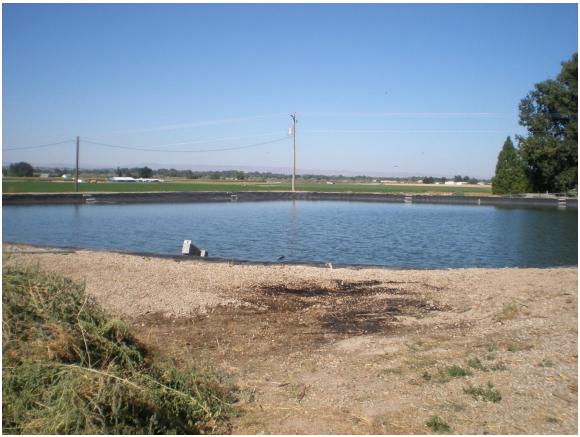
Figure 18. Looking southwest at Lagoon 3.

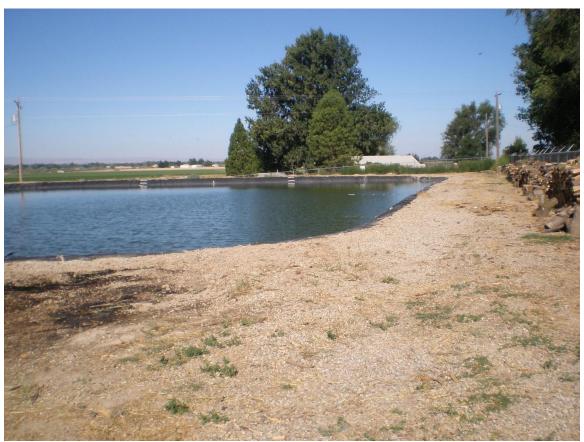
Figure 19.Looking west along north berm of Lagoon 3.

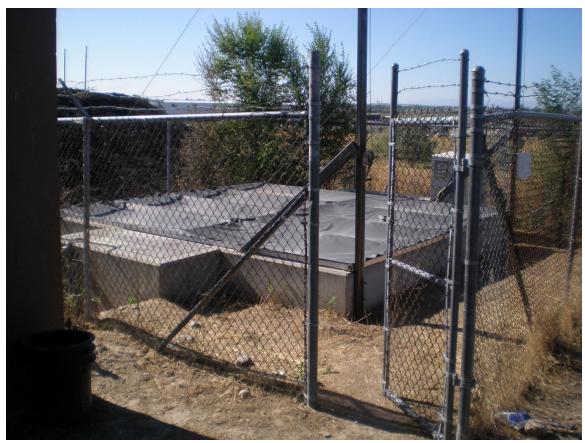
Figure 20. Chlorine contact chamber (under tarp).

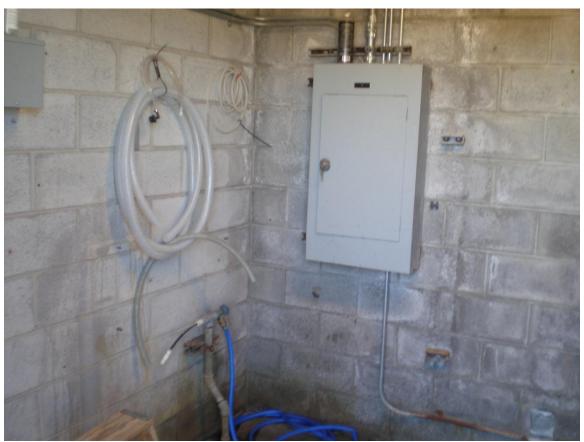
Figure 21. Electrical panel in hypochlorite treatment building.

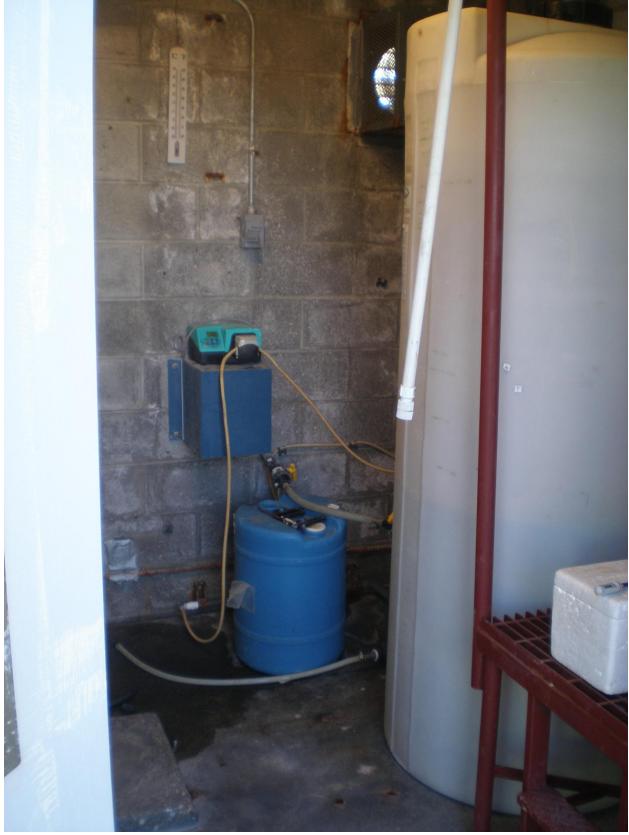
Figure 22. Hypochlorite solution storage tank (large white tank at right) and dispenser (at left).

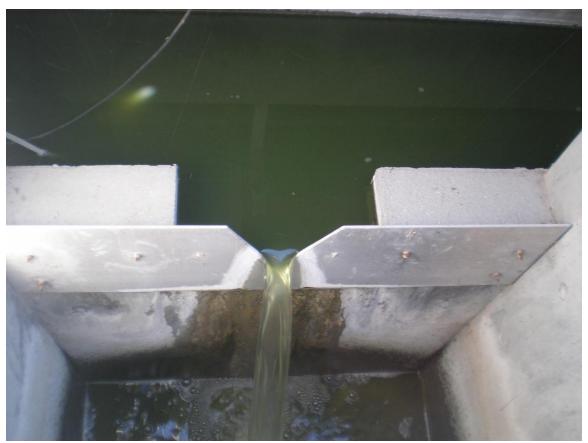
Figure 23. Plant effluent weir. Ultrasonic flow meter is mounted above the v-notch weir shown.

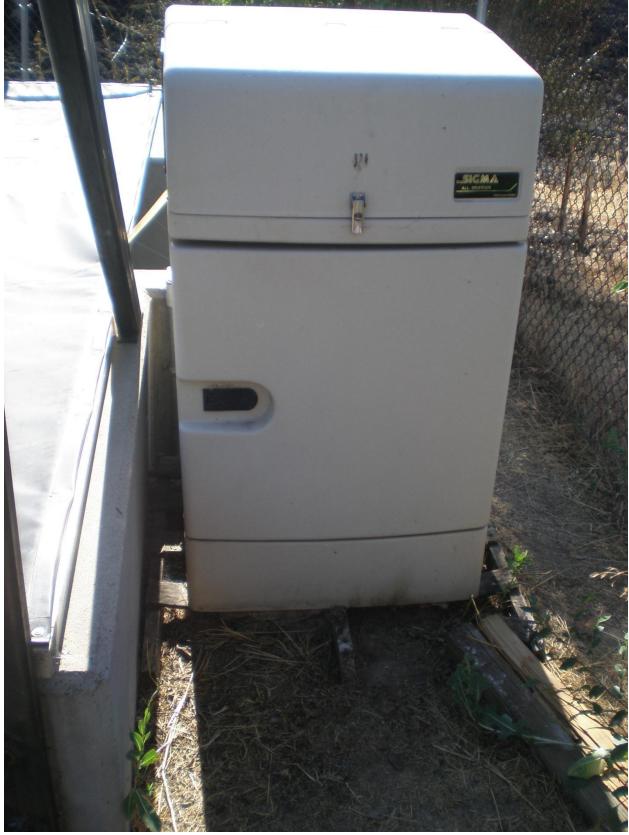
Figure 24. Composite sampler for effluent samples.

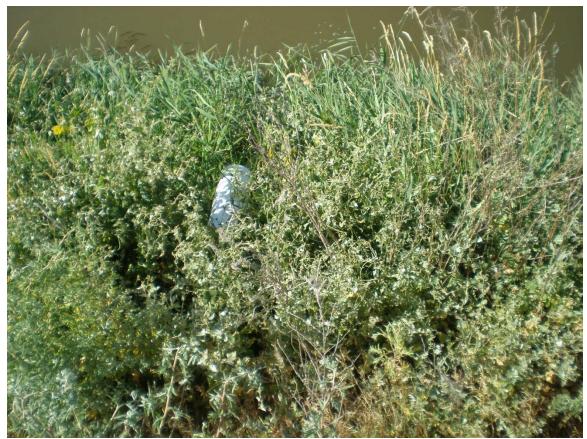
Figure 25. Outfall 001 discharge pipe (white PVC in weeds) to Sebree Canal.

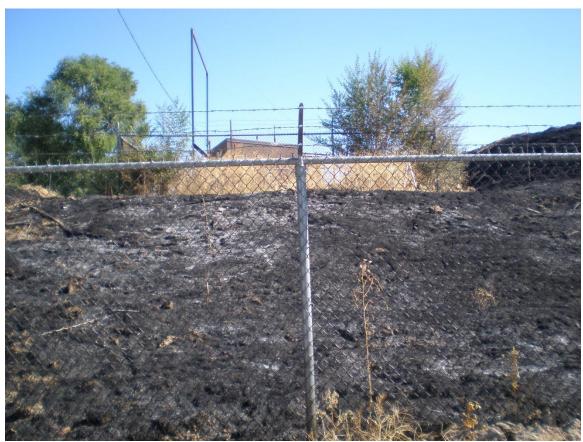
Figure 26. Looking north from Outfall 001 to plant treatment building (left of center).
